# LJUBLJANICA CONNECTS

LIFE10 NAT/SI/142

## RECONSTRUCTION OF THE SILL IN ZALOG

Action: C1

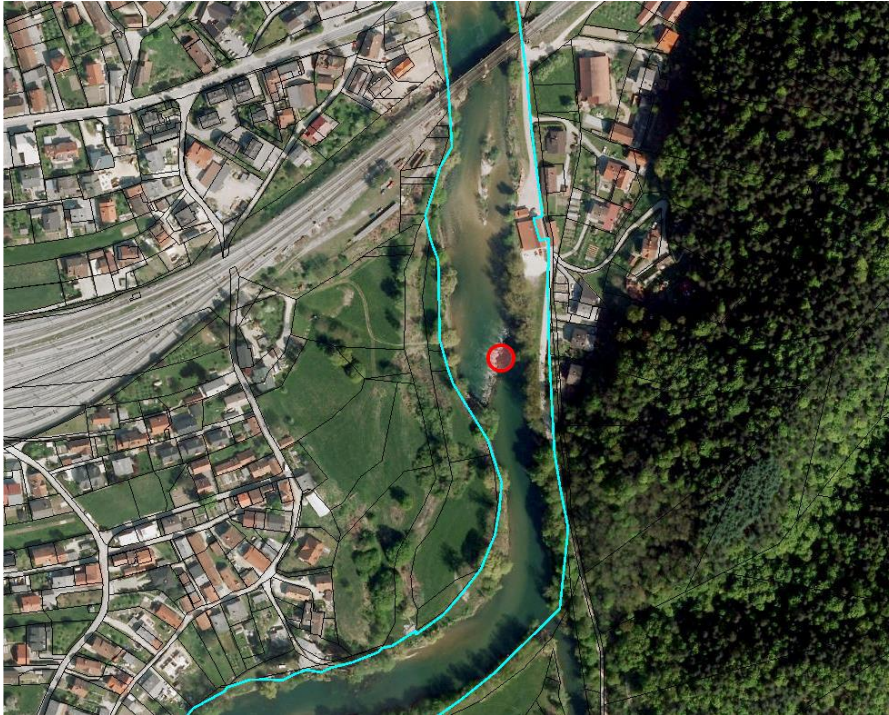
Figure 1: Location of the sill and regulation areas under action C1

This sill is a stone structure (on the figure below it is marked with a red circle) which regulates the water level in the upstream section of the Ljubljanica. The structure plays an important role in preserving the stability of the existing riparian buildings. In the event of its break or any other reason for its disfunctionality (as it was before the reconstruction) the water level upstream would be lowered considerably, which could be devastating for the fish and other water organisms, particularly during low flows. The consequence of sill break would be also the failure of existing bank protections, because the foundations would be “in the air”.

Prior to the restoration the sill was heavily damaged. In some places there were gaps as a consequence of the rocks carried away. The damage was most extensive along the left bank.

The restoration works consisted of filling these gaps on the upstream side of the sill and additional sill stabilisation at the appropriate level by placement of two sets of larger rocks. The rocks were placed individually allowing for larger gaps, so that fish migration was enabled. After the implemented stabilisation of the sill its stability and upstream water level are preserved, which is proven with the measurements as part of ecohydrological monitoring (action E3). Because prior to the reconstruction, the damages were not of such a magnitude as to cause the inability of fish migration upstream the sill (both during low flows and medium flows), the supporting frame itself and the stilling basin were not interfered with in the restoration. The restoration works were implemented in a way to allow for stability of the sill, preserve fish passability, and establish a favourable habitat for fish and other water organisms. Next to the sill we had to stabilise approx. 18 m of the right bank along the sill. The executed works were divided into two segments, i.e. the works for sill stabilisation and rehabilitation works of the damaged right bank.

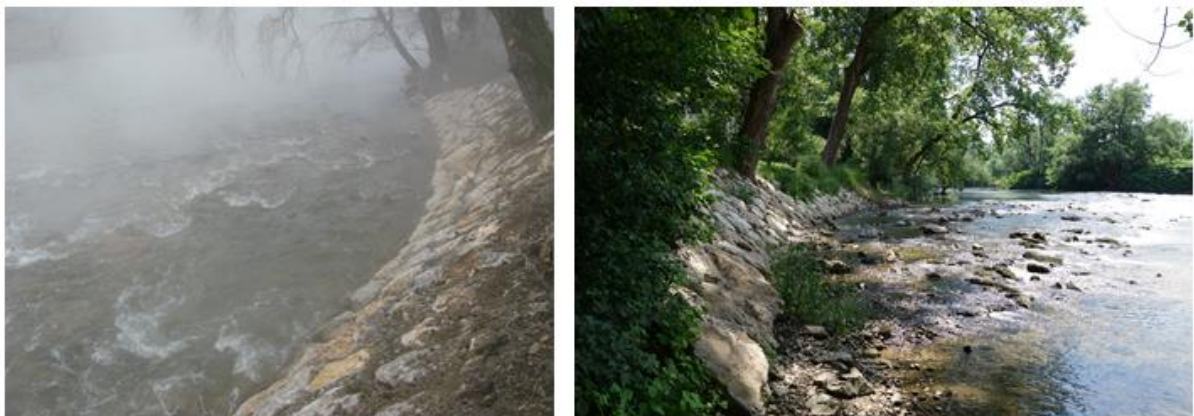
Figure 3: The restored right bank right after the completion of works in October 2013 (left) and in the summer of 2015 (right).

Prior to the restoration works, the right bank in the sill area was visibly damaged, while during the execution of works additional minor damages occurred on the sill. The bank was rehabilitated in a length of approx. 18 m. The height of the bank in the affected section was around 2.9 m. The bank was profiled in a gradient, i.e. between 1:1.3 and 1:1.15, so that it was adjusted to the previous situation as much as possible and the stability provided. Up to a height of 2 m, the bank was secured with riprap with stones of a size of 50–100 cm, while the rest of the bank was well stabilised and planted by sowing grass and planting willow saplings.

The protection with stone was put in place in a way that allowed for the laying of stone in the designed profile. The individual stones have a secure position and were, in the final stage, anchored so that no riverbank failure could occur due to the instability of the individual rocks. Only rocks of a thickness from 0.5 (at the top) to 1.0 m (in the foundation) were placed. Special attention was placed on the stability of the toe of the riprap. The gaps between the stones of the riprap were filled with the material dredged from the stream and anchored with smaller stones. The gaps in the upper part of the bank were covered in greenery, i.e. with sown grass and planting of willow saplings. The riprap was installed with machinery. The exterior surface of the riprap is rough, while the smooth faces of the stones face inwards. The individual overly large or protruding stones were placed in some places at the toe of the bank. The transitions between the different gradients of the riprap are continuous. The transition between the bank and the riparian zone is also continuous, i.e. not sharp.

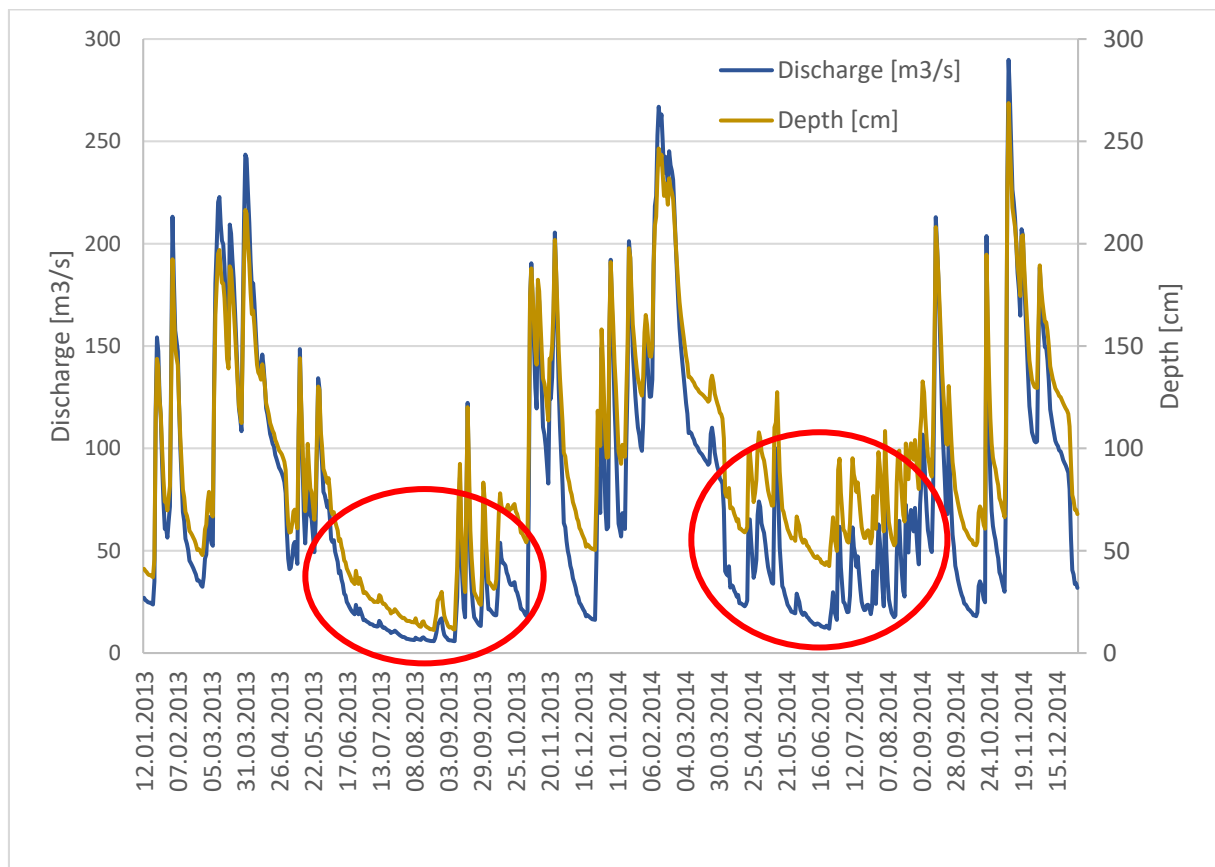
After the restoration, we have monitored the water level in the proximity of the sill and compared it with the water levels prior to the restoration measures. The raising of the water level was observed soon after the execution of works, while the measurements are continuously monitored under action E3 (Figure below).

We have the data on the discharge only until the end of the 2014, because the Slovenian Environment Agency (ARSO) has not yet published subsequent official data on discharge.
