LIFE10 NAT/SI/142 Progress Report

Covering the project activities from 01/01/2012 to 30/01/2015

Restoration of the Ljubljanica River corridor and improvement of the river's flow regime

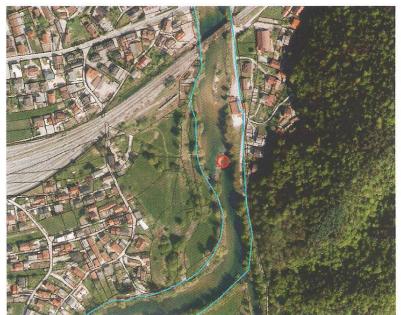
Slika 1: prikaz območja ureditve - prag v Zalogu

Prag se nahaja na Ljubljanici v Zalogu nad železniško progo Ljubljana - Zidani most. Reka Ljubljanica na dani lokaciji predstavlja naravno vrednoto državnega pomena. Pri izvedbenih delih izvedenih v skladu s tehnično dokumentacijo za vzdrževalna dela projektanta Hidrotehnik d.o.o., Slovenčeva 97, 1000 Ljubljana, št. projekta: R-481/13, julij 2013 potrjeno s strani Ministrstva za kmetijstvo in okolje, Agencije Republike Slovenije za okolje, Oddelek območja Srednje Save. Prav tako je bilo upoštevano naravovarstveno soglasje Ministrstva za kmetijstvo in okolje, Agencije Republike Slovenije za okolje kot tudi soglasje Zavoda za ribištvo Slovenija (ZRS). Soglasje Zavoda za varstvo kulturne dediščine ni bilo potrebno.

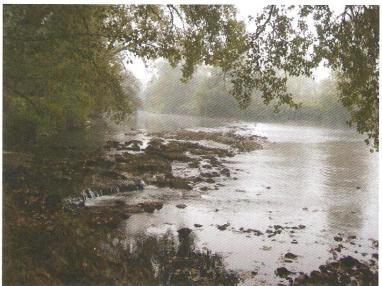
Gre za kamniti prag, kateri drži niveleto Ljubljanice na gorvodnem odseku. Objekt igra ključno vlogo pri ohranjanju stabilnosti obstoječih obrežnih zgradb. V primeru njegove porušitve bi se nivo vode gorvodno bistveno znižal, kar bi predvsem v primeru nizkih vodostajev lahko imelo uničujoč vpliv na ribe in ostale vodne organizme, hkrati pa bi lahko prišlo do porušitve obstoječih obrežnih zavarovanj, saj bi bili temelji v »zraku«.

Slika 2: prag v Zalogu pred posegom - vidne poškodbe ob levi brežini

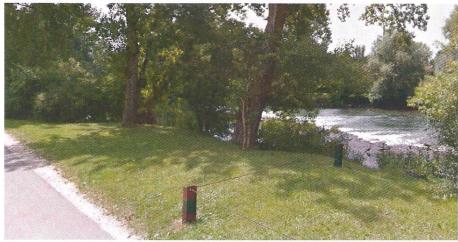
Slika 3: lokacija dostopne poti do struge

Obstoječo obrežno zarast se je ohranilo v največji možni meri. Na mestih kjer se je zaradi dostopa odstranilo vegetacijo, se je posek izvedel na način, da je omogočal njeno vzpostavitev v prvotno stanje. V koreninske sisteme se ni posegalo. Redčila so se posamezna manjša drevesa in veje. Debla večjih dreves se je ohranilo.

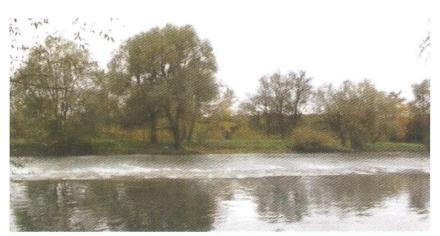
Slika 4: prag v Zalogu po sanaciji

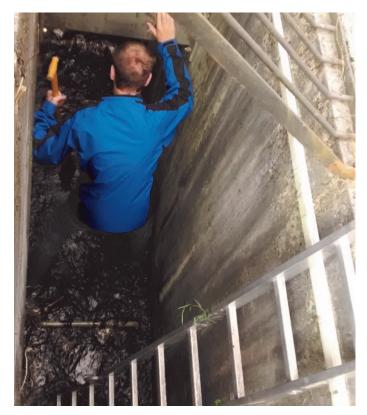
Priprave na meritve v stezi

Študentka, ki piše diplomo v povezavi s projektom, je ob pomoči dveh naših raziskovalcev v ribji stezi na Ambroževem trgu izvedla meritve hitrosti in globine vode. Pri meritvah smo uporabili SonTekov Dopplerjev merilec pretočnih hitrosti FlowTracker Handheld ADV, s katerim lahko natančno izmerimo pretočne hitrosti. Pretočne hitrosti smo izmerili v več ključnih točkah vzdolž ribje steze. Meritve smo opravljali v notranjosti steze, ki je vkopana v breg reke Ljubljanice.

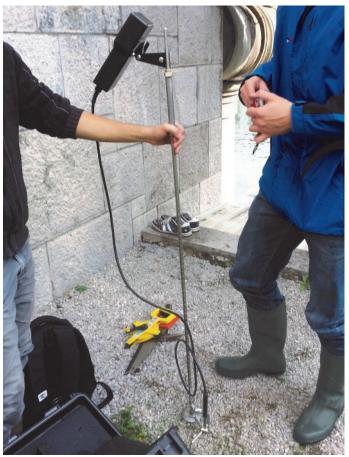
Merski časovni interval na posameznem merskem mestu je bil 45 s. Poleg hitrosti smo izmerili tudi dimenzije prekatov in globino vode v posameznih prekatih. S tem smo preverili, če ribja steza omogoča nemoten prehod rib.

Merilec pretočnih hitrosti

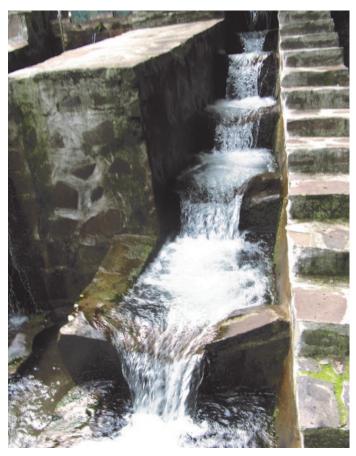
Po tem smo sledili toku reke in si z avtobusa ogledali meandrirajočo strugo, ki teče po zaščitenem območju Natura 2000. Ogledali smo si tudi zaporedje manjših vodnih pregrad Dolný Harmanec, ki z vodo oskrbujejo eno izmed najstarejših hidroelektrarn na Slovaškem ter dve novejši mali hidroelektrarni, v sklopu katerih sta bili zgrajeni tudi ribji stezi. Prva mala hidroelektrarna, ki smo si jo ogledali, leži na območju manjših rek Motyčky – Jelenec in je v lasti privatnika, ki je njeno upravljanje prevzel od očeta ter temeljito obnovil hidroelektrarno.

Ribja steza na mali hidroelektrarni

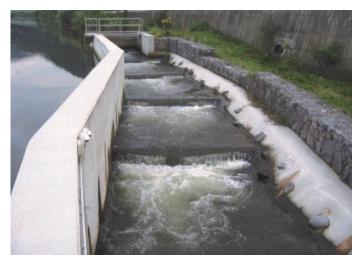
Na koncu smo si pod vodstvom projektanta ogledali še malo hidroelektrarno Hronská Dúbrava na reki Hron. Čeprav tudi ta objekt spada v skupino malih hidroelektrarn, je bil veliko večji od prve, ki smo si jo ogledali, saj izkorišča moč večje reke. Sorazmerno s tem je večja tudi ribja steza, ki smo si jo ogledali v sklopu te hidroelektrarne.

Ribja steza na mali hidroelektrarni Hronská Dúbrava

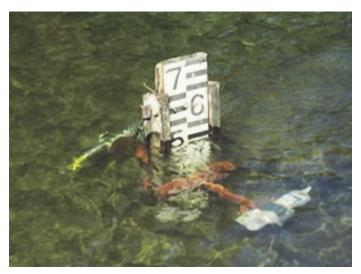
Pretočne hitrosti lahko zmerimo z uporabo instrumentov, ki delujejo na principu Dopplerjevega pojava.

Hidrometrično krilo (levo) in instrument Starflow (desno)

Za merjenje pretočnih hitrosti lahko uporabimo tudi instrument Starflow. Ultrazvočni merilec Starflow je instrument, ki se uporablja za merjenje pretočnih hitrosti, globine in temperature vode. Zasnovan je tako, da se namesti na dno vodnega kanala.

Za merjenje hitrosti vode merilec Starflow izkorišča delce, ki se gibljejo z vodo. Če poznamo hitrost zvoka v vodi, lahko izračunamo hitrost odboja in posledično dobimo povprečno hitrost okoliške vode. Hitrost vode lahko izmeri v obe smeri. Ta lastnost je zelo uporabna pri merjenju pretokov rek, ki so pod vplivom plimovanja, ali so regulirani z zapornicami oziroma tam, kjer se pojavlja povratni tok.

Instrument meri tudi temperaturo vode, ki jo uporablja za izračun hitrosti zvoka v vodi.

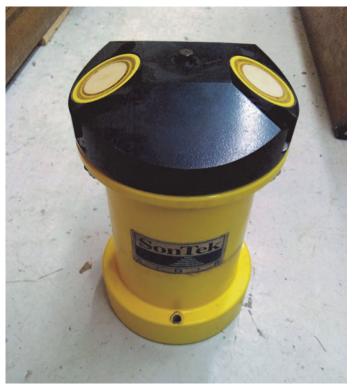
Dopplerjev pojav je fizikalni pojav, kjer zaradi gibanja vira, opazovalca ali obeh nastane navidezna razlika v valovni dolžini zvoka. Zvočni valovi, ki prihajajo od objektov premikanja oziroma se od teh odbijajo, se od zvočnih valov objektov, ki mirujejo, razlikujejo po višini tona. Hitrost in smer delcev, ki se v vodi premikajo (lebdeči delci, majhni zračni mehurčki), se lahko izračunata s pomočjo Dopplerjevega pojava. Primer instrumenta, s katerim lahko merimo pretočne hitrosti, je merilec Sontek ADP. Ta instrument deluje na podobnem principu kot merilec Starflow s tem, da ga ne namestimo na dno vodotoka, ampak v brežino struge.

Merilec pretočnih hitrosti Sontek ADP

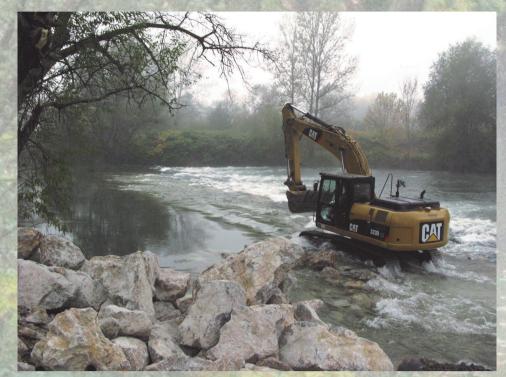
Obnova praga v Zalogu

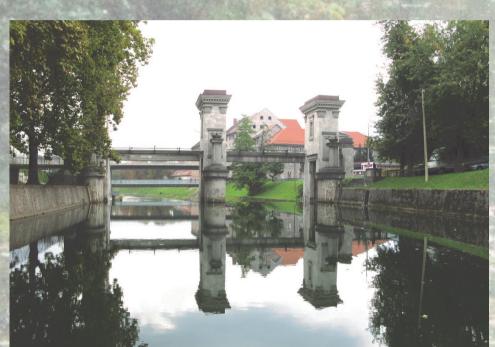
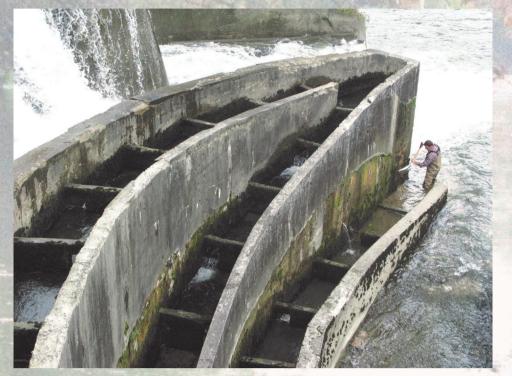
Obnova ribjega prehoda ob Fužinskem jezu

in November 2013 fish pass in Fužine has collapsed which resulted in need to prepare new reconstruction plans. They had to be planned more carefully due construction which is more worn out as expected. We have prepared new plans which showed that the costs of newly proposed reconstruction are much lower due to reconstruction of a whole fish pass and not only its parts separately. Reconstruction of whole object is less complicated and Figure 7: Collapsed fish pass therefore cheaper.

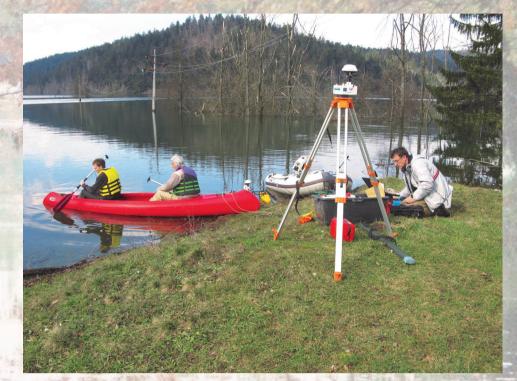
Meritve na Planinskem polju

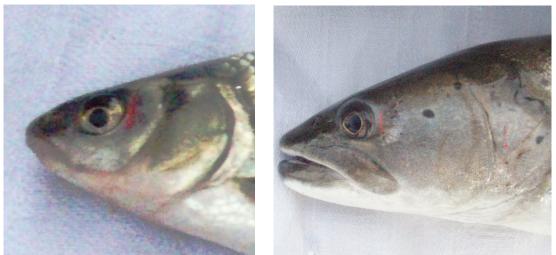
During the research there have been marked 6 Danube Salmons, 14 Danube Roaches and 27 Common Nases. The fish were marked with injecting of red or yellow colorant into the subcutaneous tissue behind the eye (figure 1) or into dorsal fin (figure 2).

Figure 1: Injecting into subcutaneous tissue behind the eye (left: Danube Roach, right: Danube Salmon)

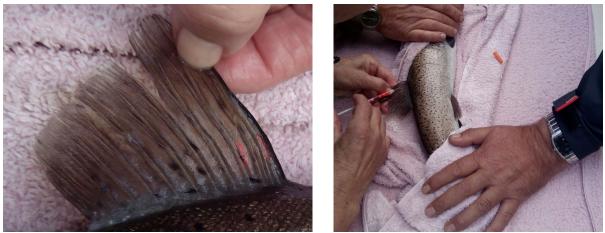
Figure 2: Injecting into dorsal fin
