# LJUBLJANICA CONNECTS

LIFE10 NAT/SI/142

## IMPROVEMENT OF THE AMBROŽEV TRG BARRIER – UPDATING THE GATE LIFTING SYSTEM AT AMBROŽEV TRG

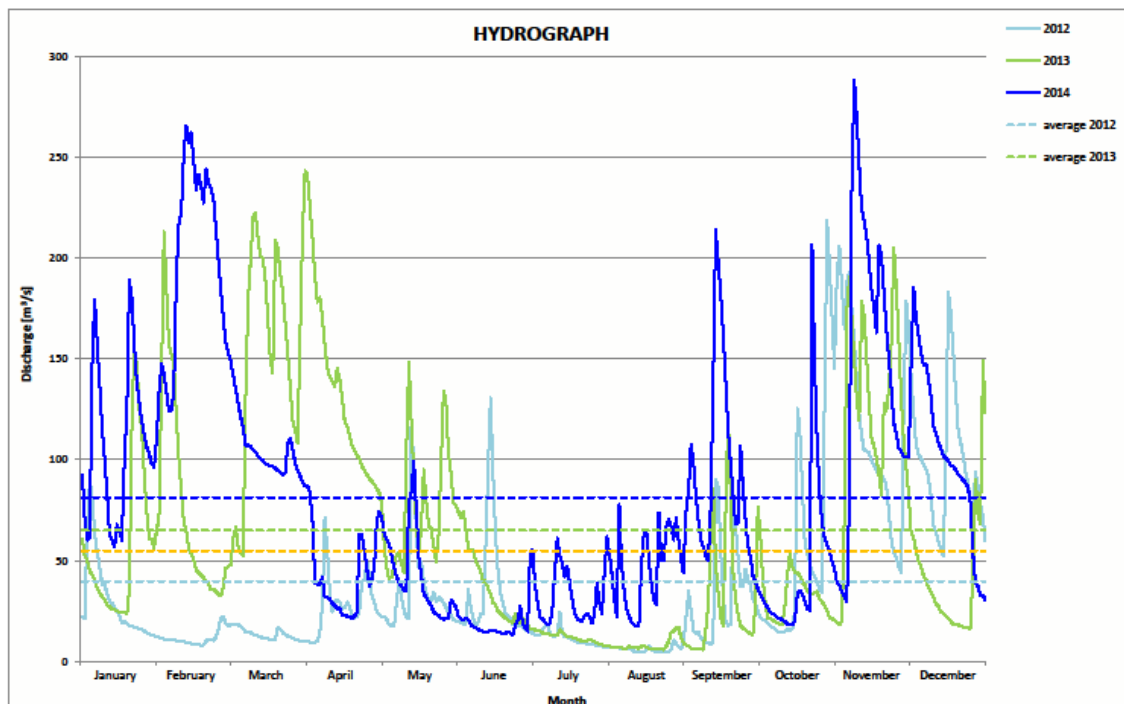
Figure 1: Hydrograph of the Ljubljana River at Moste

From hydrograph we can see that in comparison with water discharge in year 2012 (light blue curve) the discharge was higher for the whole time in year 2013 (green line) except in August and almost through the whole year 2014 (blue line). The most obvious exception is caused by high water peak in June 2012. There is a big difference between discharges in those three years especially in February and March 2014 when water was much higher than it was in previous years (maximum difference in discharge between 2012 and 2014 is more than 250 m<sup>3</sup>/s in late February which exceeds even the maximum discharge in 2012).

Average values of discharge shows that in year 2013 discharge was approximately 25 m<sup>3</sup>/s higher than in year 2012 and 10 m<sup>3</sup>/s higher than long term average (measured from 1947 to 2013). Differences in average annual discharge are even higher in year 2014 when average annual discharge was higher for 40 m<sup>3</sup>/s in comparison with average value from year 2012 and for 26 m<sup>3</sup>/s than long term average.

Next to the problems of selecting the contractors and adjusting the actions, these delays were also due to very high flows of the Ljubljanica in 2013 and 2014, as reported in the Progress Report No 2 (reporting date 29 January 2015) (Figure 1, Figure 2). During the execution of the works the gates were non-operational, so we needed to make sure that there would be no need to use the gates to regulate the water level for at least 14 days. For the duration of the work on the gates, the Hydrological Forecasting Office of the Slovenian Environmental Agency (ARSO) provided us with flow forecasts for the next days, based on meteorological forecasts. The delay in this action did not affect the implementation of other actions.

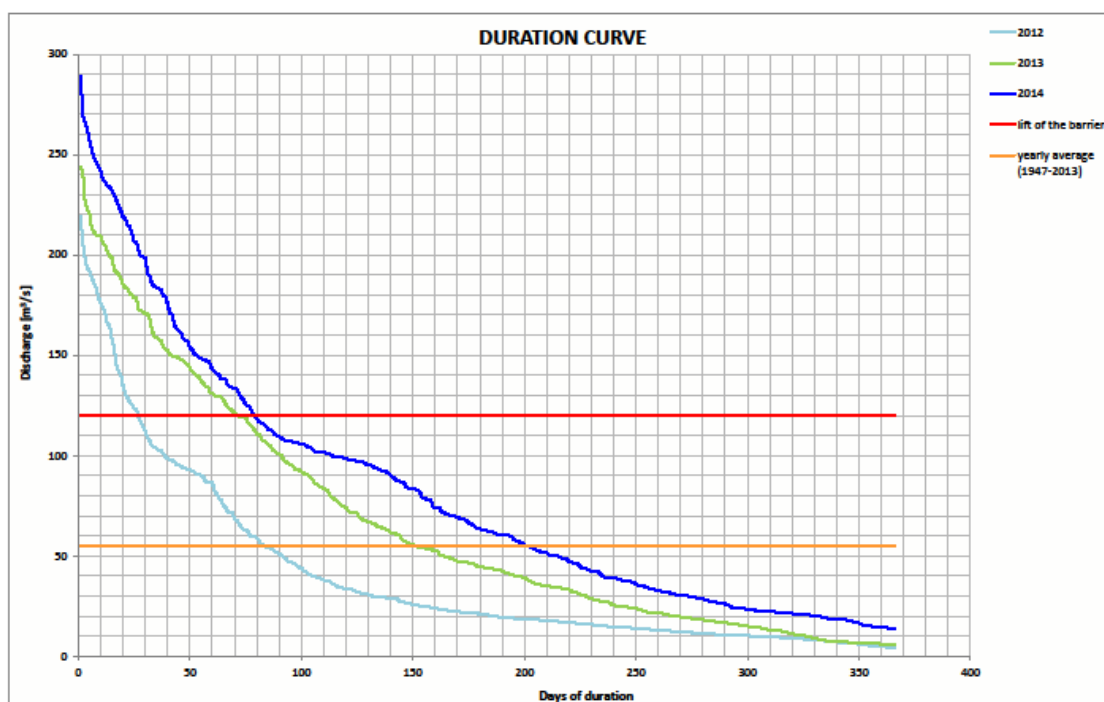
Figure 2: Duration curve of the Ljubljana River at Moste

On duration curve there is presented number of days when discharge was at least a certain value on y axis; for example minimum discharge in year 2014 was equal to 13 m<sup>3</sup>/s, therefore in every day of the year the discharge was at least as much or more so duration of that discharge was 365 days.

From duration curve we can see that measured daily discharges were lower than long term average discharge for 280 days in year 2012, for 215 days in year 2013 and only for 160 days in year 2014.

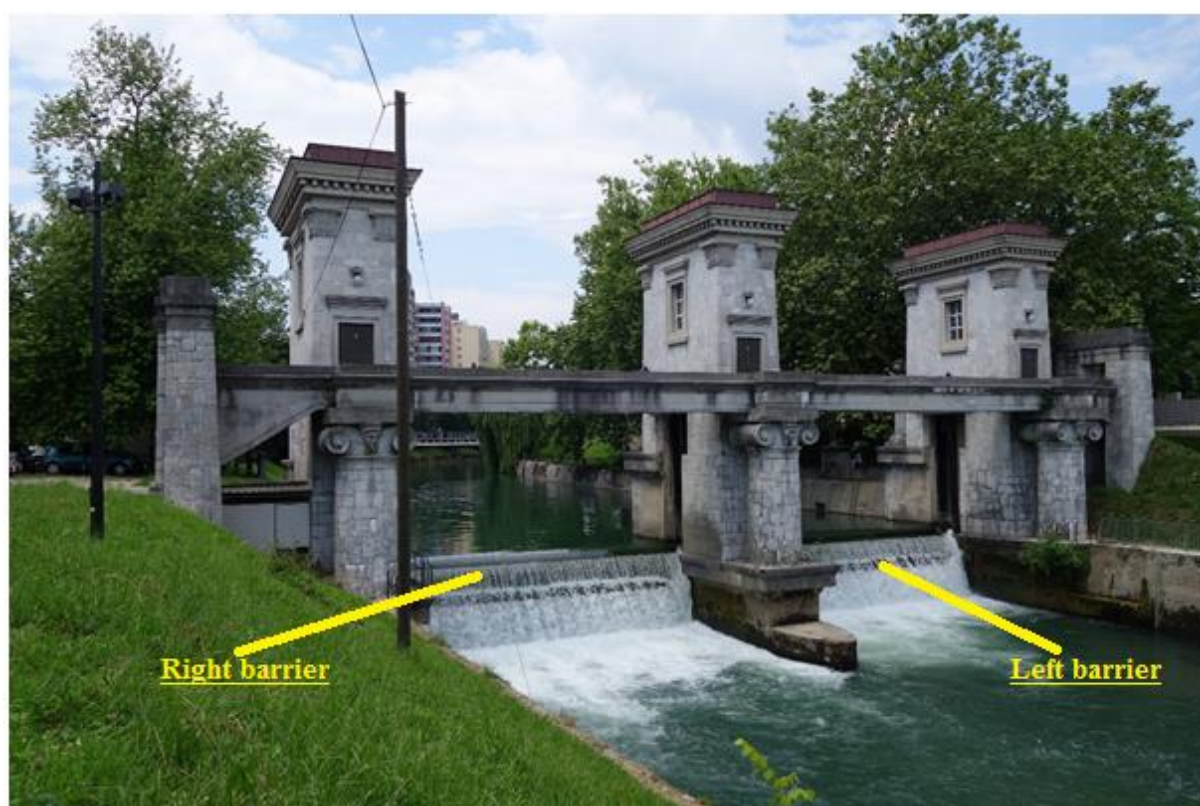
Figure 3: Sluice gates at Ambrožev trg

Under action C3 we reconstructed and updated the mechanical and electrical equipment at Ambrožev trg gate for regulating the flow up to 10 m<sup>3</sup>/s below the gate during the low flows of the Ljubljanica. The gate lifting system was redesigned in a way to allow the travel of the gate of up to 200 mm above the weir with a fine regulation of the orifice with a minimum increment of 5 mm. The lift of the gate above 200 mm remained unchanged. The improved lifting system thus allows for a continuous regulation of low flows, which is hugely important for the conservation of favourable ecological conditions on the Ljubljanica river for various living organisms, particularly the target species in our project: striped chub (*Leuciscus souffia*), Danube salmon (*Hucho hucho*), and Danube roach (*Rutilus pigus*).

In June 2015 we started the procedure of selecting the relevant contractor for implementing the reconstruction measures of the gate lifting system. Due to the complexity of the implementation requirements we were limited by the number of appropriate, i.e. competent operators. The tender process for selecting the most favourable provider was guided separately for both the reconstruction of mechanical equipment and the reconstruction of electrical equipment. The latter led to complications and, eventually, repetition of the procedure, as the originally selected tenderer withdrew from the tender. Namely, the same tenderer also made a bid for the reconstruction of mechanical equipment of the sluice gate; however, the bid was not the most favourable and was not selected. Then, the selected provider delayed with the signing of the contract for reconstructing the electrical equipment and finally, by agreement, withdrew from the bid. Therefore, the selection procedure for the reconstruction of the electrical equipment had to be repeated. All of this prolonged the start of works at the gate which started in August 2015 and ended in September 2015 (Figure 3).

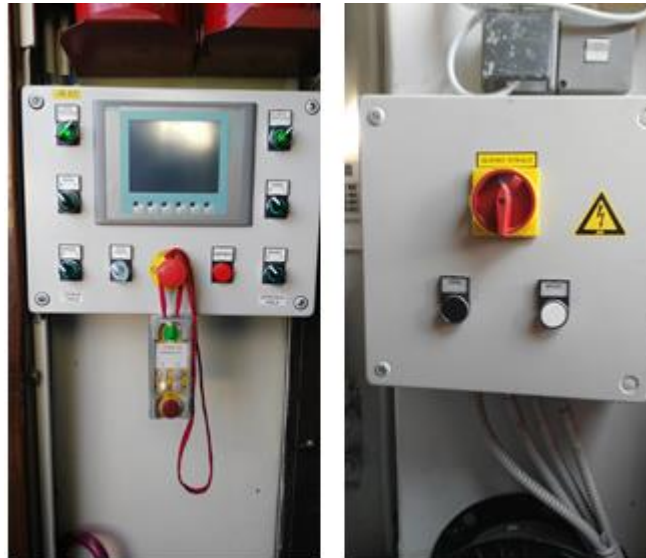
Figure 4: Touch screen indicating the position of the gate (left) and the main switchboard (junction box) (right)

After the implemented reconstruction works the operator had the option of determining the openness of the lower gate. The gear of the drive mechanism was installed with an absolute

encoder sending signals to the controller, based on which it calculates and shows the position of the gate on a touch screen. The on-screen control panel is designed to serve the input of the new desired position of the gate. The controller was equipped with a module with a connection to the Ethernet, which will in the future allow for connection to the Internet, sending of information about the gate, and the potential distance-controlled gate operation.

The machinery part of the gate reconstruction consisted of installation of a new electric motor with a manual drive option, production of a mechanical indicator of the situation of the gate and of the parts necessary for the installation of measuring equipment of the position of the lower gate. A new junction box was installed for the right gate, where all the necessary elements for a safe and reliable gate operation are installed. The controller installed in the junction box allows for both automatic and manual adjustment of the river flow below the right lower gate according to the data received (increment of 5 mm). All the relevant data are displayed on the operation panel installed on the doors of the new junction box. In the future we will be able to transfer these data via the existing communication system or wireless to a predefined point.
