LIFE Project Number
LIFE10 NAT/SI/142

FINAL Report

Covering the project activities from 01/01/2012 to 31/08/2016

LIFE+ PROJECT NAME or Acronym
Ljubljana Connects

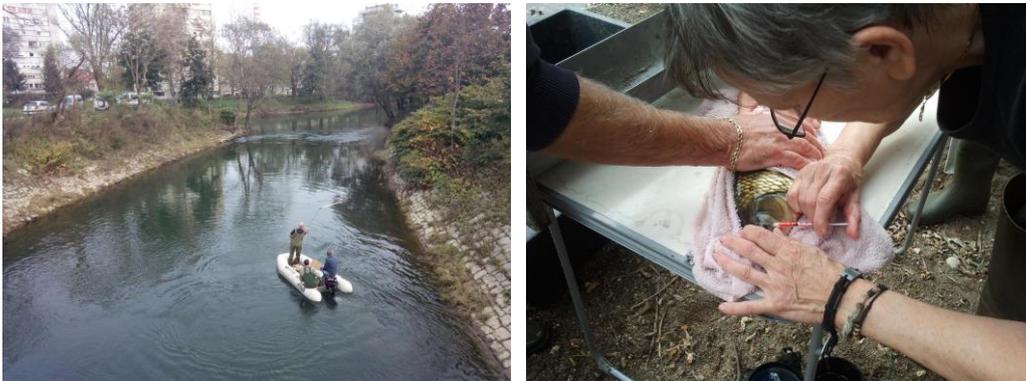
Figure 4: Catching of fish, measuring its characteristics, and marking using VIE methodology

- Electrofishing, measurements and marking of fish in cooperation with expert Meta Povž, PhD, ichthyologic society and fishing associations Barje, Vevče, Dolomiti, and Vrhnika (carried out on 18 September 2013 and 26 September 2013, and 15 June 2015). The reports on the fish tagging and sampling can be found in Annex 2 and Annex 3.

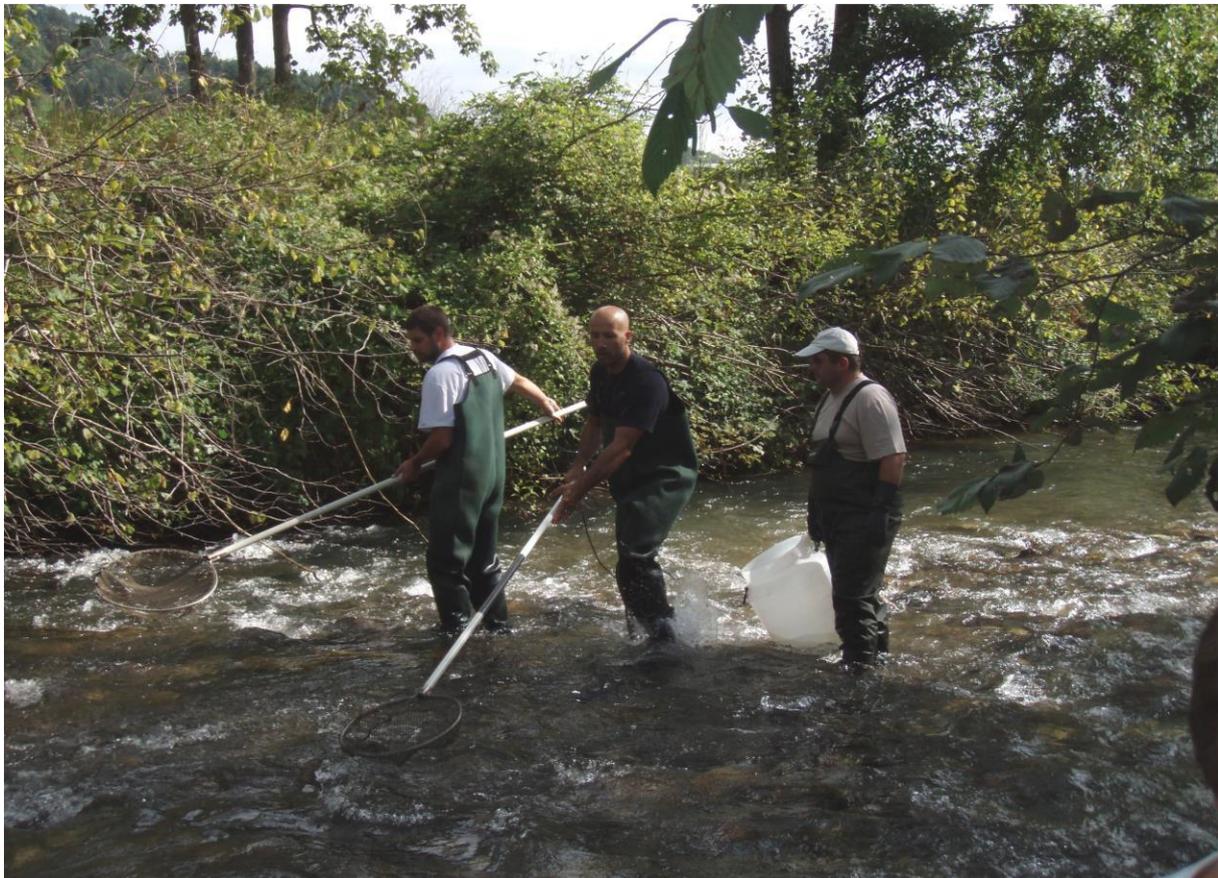
Figure 5: Electrofishing of 15 June 2015

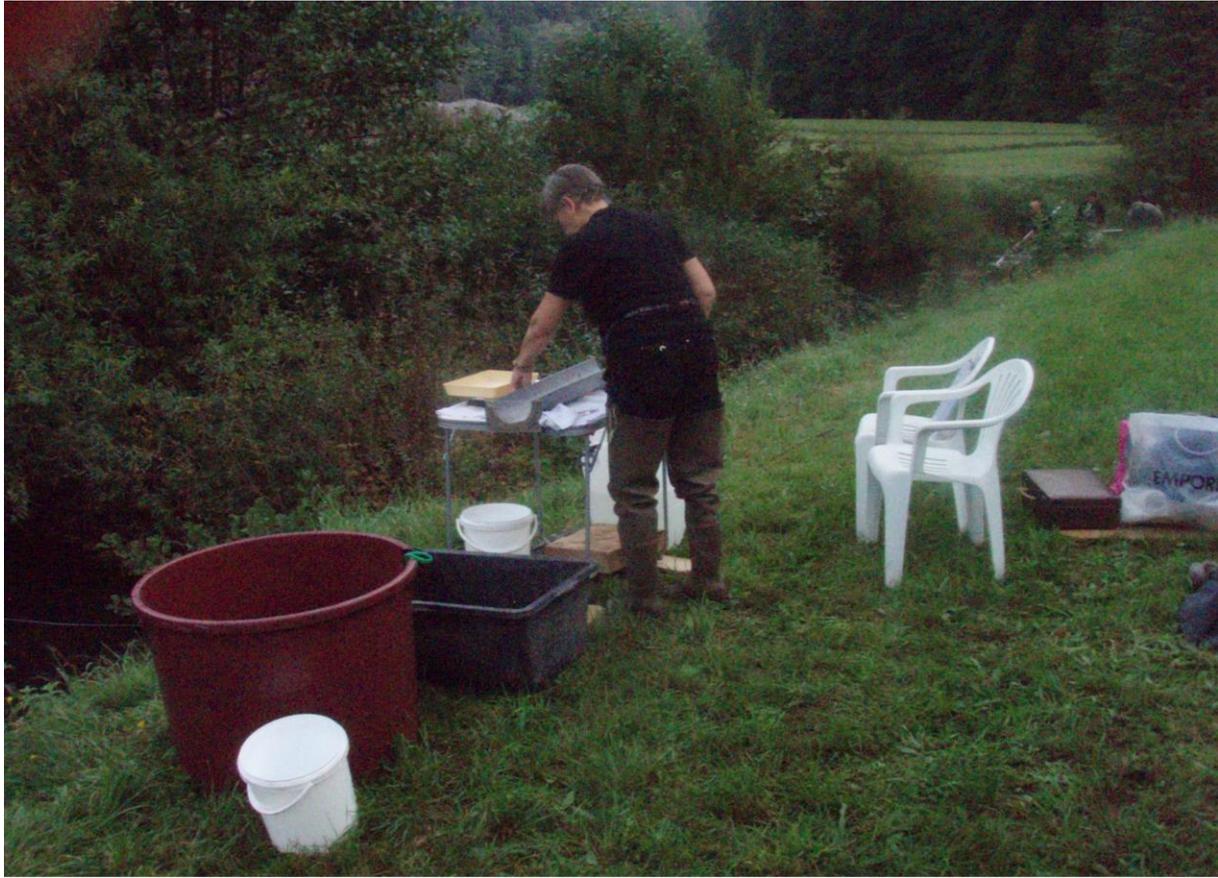
Figure 6: Preparation for measurements of length and weight

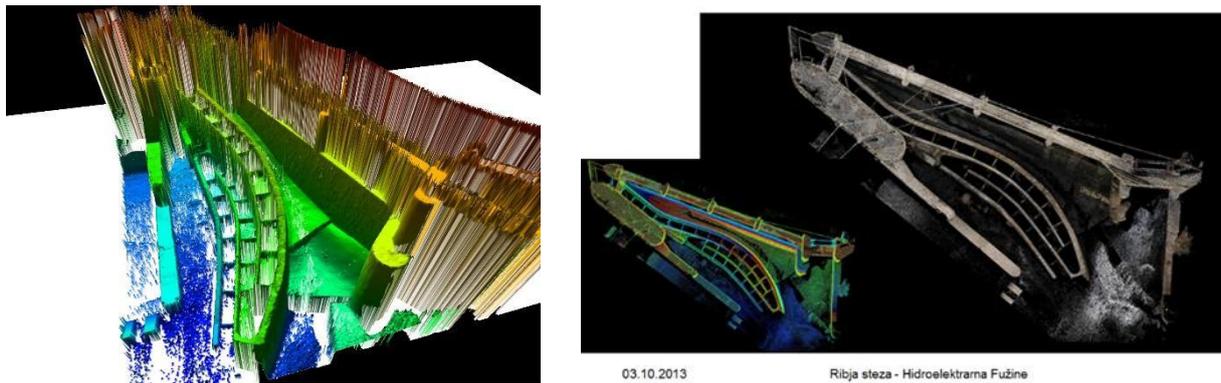
Figure 8: Recordings of the fish pass at Fužine weir, produced by terrestrial laser scanning

Detailed data on geodesy and terrestrial laser scanning were obtained in autumn 2013. The geodetic plans were produced by Tadej Srdinšek s.p.; the company was selected by Purgator. Terrestrial laser scanning provided a more detailed look at the structure and helped the designer in the fish pass restoration design at the Fužine weir, which collapsed in autumn 2013 due to high flows, so the measure had to be revised (Figure 8). For the reconstruction of the sill in Zalog detailed geodesy of the sill was prepared (Annex 12).

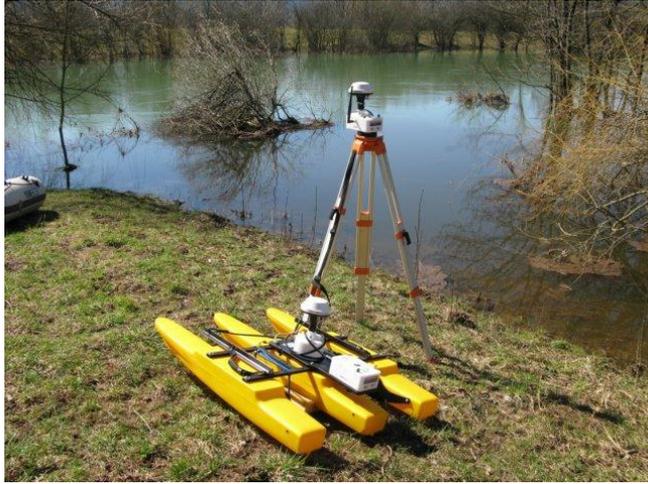
Figure 9: Radio-controlled boat “Hi3”

Based on the data obtained from action A1, in December 2013 the initial hydraulic model of the Ljubljana River was developed. The model was developed by the University of Ljubljana, Faculty of Civil Engineering, which has much experience in this field. We used Mike 11 and Mike FLOOD software. The model was later upgraded with new data obtained from the measurements made in the scope of the project Ljubljana Connects. The measurements were made by University of Ljubljana, which also developed the equipment for river/lake bottom bathymetry – a boat called “Hi3” (Figure 9). The radio-controlled boat named “Hi3” was designed and developed in order to facilitate water velocity and bathymetry measurements. The boat is equipped with the SonTek RiverSurveyor M9 instrument that is designed for measuring open channel hydraulics (discharge and bathymetry). With “Hi3” measurements can be carried out also in potentially dangerous areas such as under lock gates at hydroelectric power plant or near the turbine outflow. More information on the boat “Hi3” and its role in the project can be found in the article which was presented at the EGU 2016 conference (Annex 21).

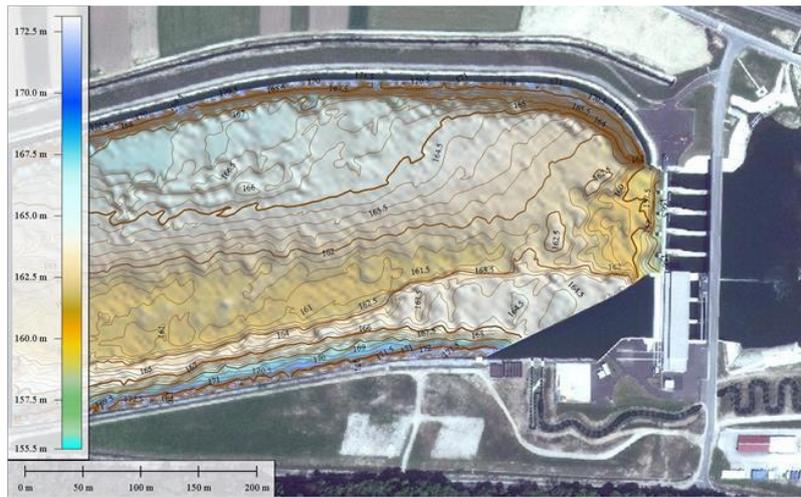
Figure 10: Results of measurements with “Hi3”

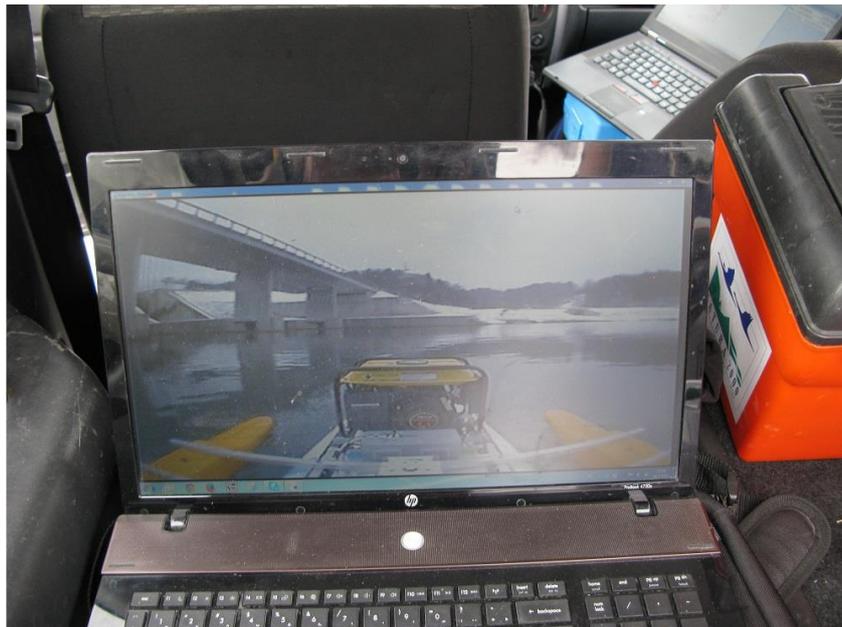
Figure 11: Camera on the “Hi3” boat for remote control

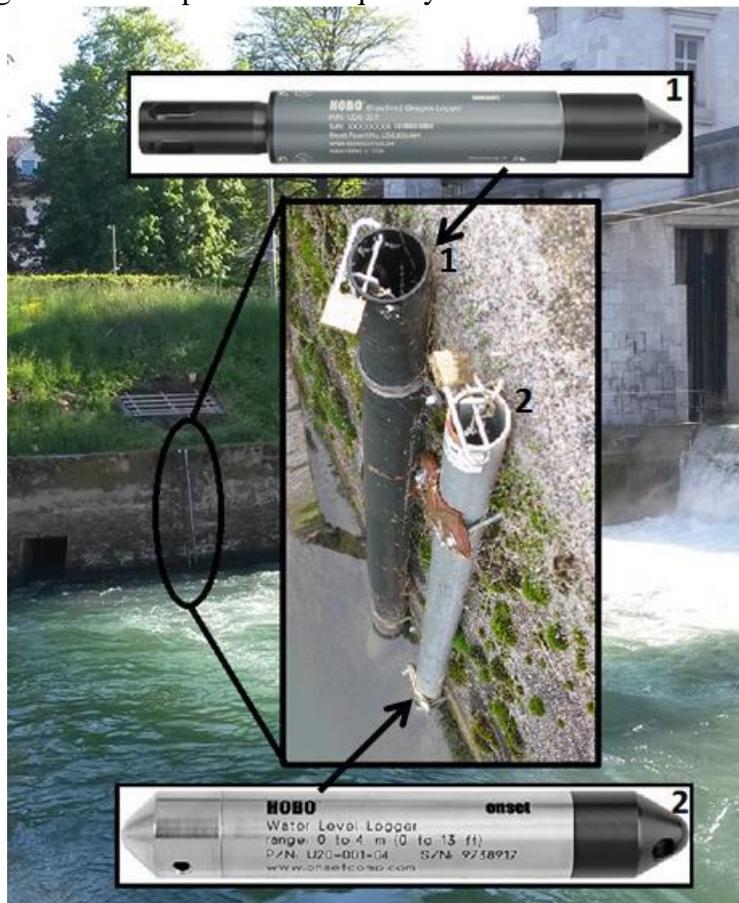
Figure 13: Sensor for measuring concentration of dissolved oxygen (1) and sensor for measuring water level (2) on the measuring site Ambrož Square, downstream of river gates

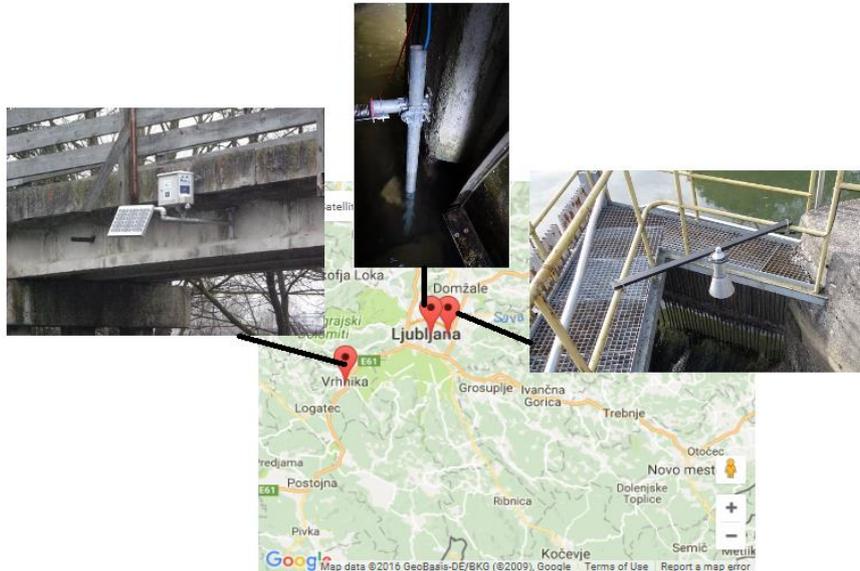
Figure 14: Locations of 3 online water stations and measuring equipment

The 3 water stations with online connection are located in the fish pass at Ambrožev trg, at the fish pass at the Fužine weir and on the bridge at Vrhnika, Močilnik, downstream of the source of the Ljubljana River (Figure 14).

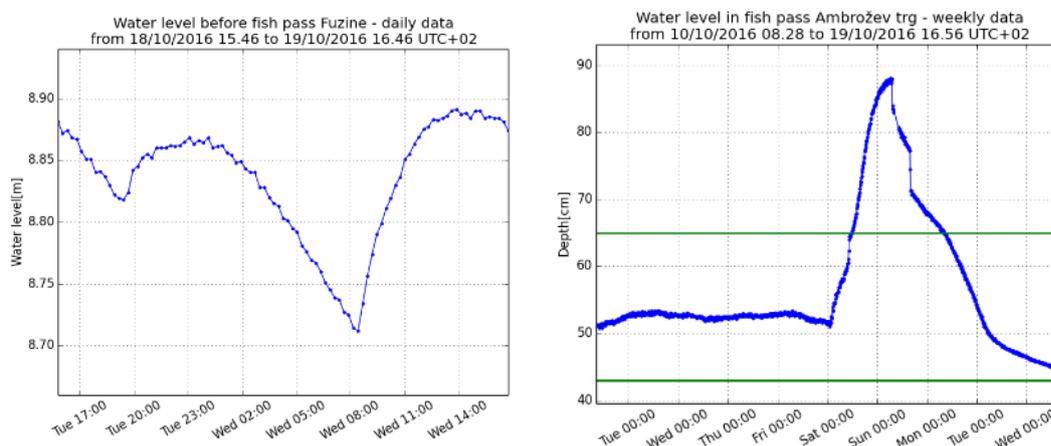
Figure 15: Example of the measured data which are available online on the website.

The recorded data can be accessed in real-time at: <http://ksh.fgg.uni-lj.si/avp/life/> (Figure 15).

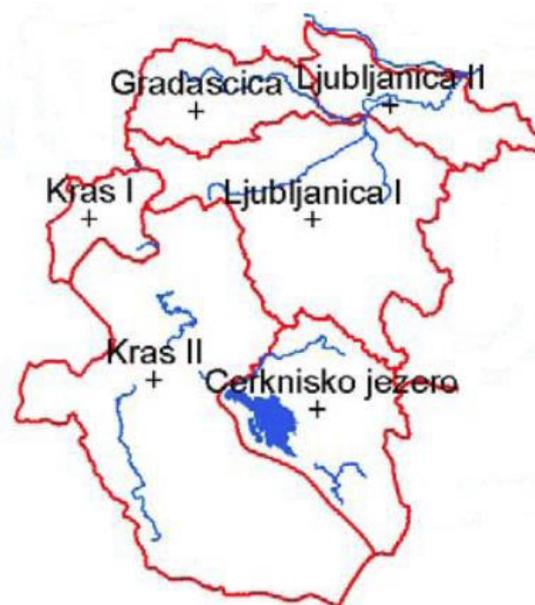
Figure 16: Sub-basins of the Ljubljanica river basin in the hydrological model

Data from various meteorological and hydrological stations are needed to make a hydrological model. Here, data from nine precipitation stations were included in the modelling (Nova vas, Sodražica, Želimlje, Črna vas, Sveti Vid, Rob, Tomišelj, Rakitna and Rakek). The data from water measuring stations were also used. The measurements are carried out by the Slovenian Environment Agency. Currently, three stations on the Ljubljanica River and three on its tributaries are operational but we also used historical data from five other stations from this area. For the purposes of modelling, hydrogeological measurements were also conducted. Water regime of the area was modelled in three stages. In the first stage, the runoff model was prepared, in the second stage, the hydraulics of the Ljubljanica River and the Iška River was modelled, and in the third, the interaction between surface water and groundwater was modelled.

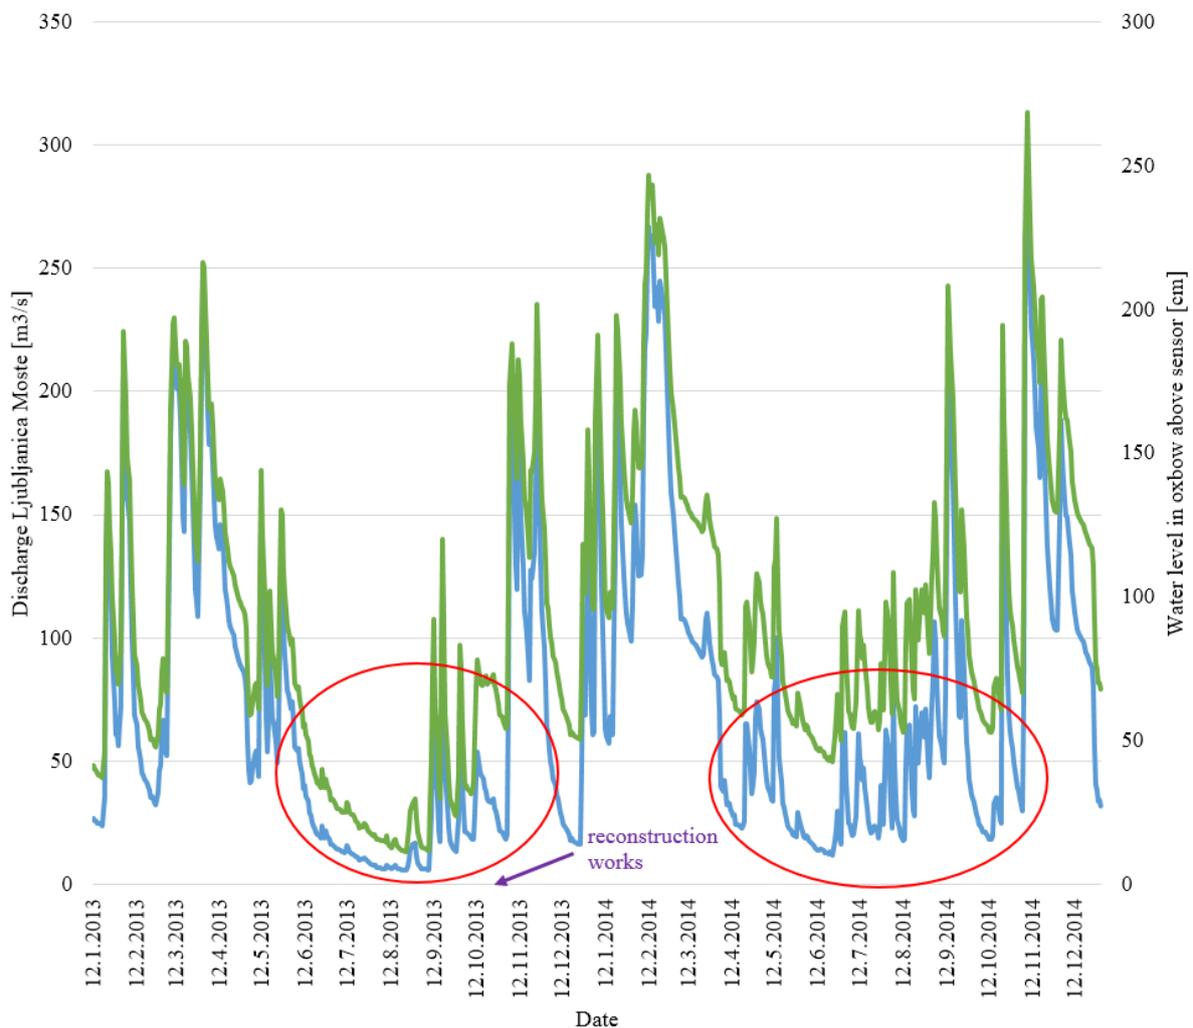
level was observed soon after the execution of works, while the measurements are continuously monitored under action E3 (Figure 18).

Figure 18: The raising of the water level in the oxbow in Zalog soon after the execution of works

Summary of the works: removal of two trees, the use of 1184 m³ material for the access road and the construction of the sill, the use of 94 m³ material for bank protection, and the planting of 18 willow saplings that would improve bank stability and help to preserve the natural appearance after the restoration. A more detailed report on the reconstruction works at sill in Zalog can be found in Annex 15.

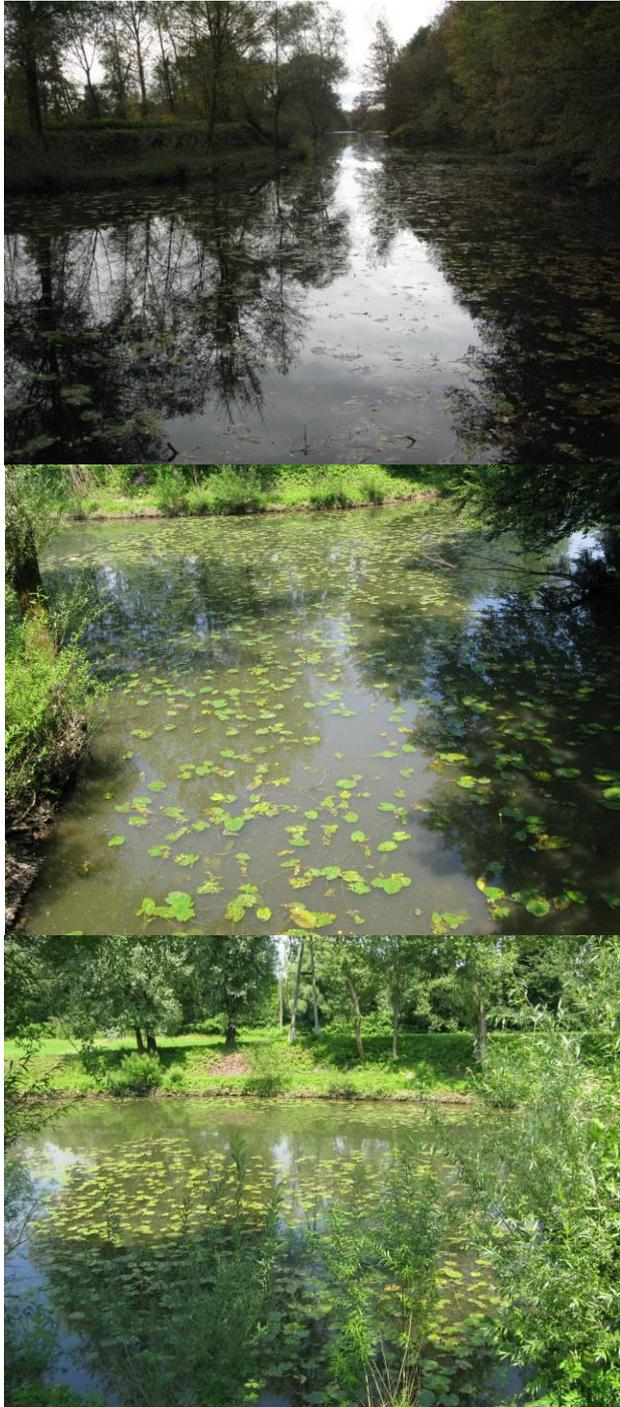
Before reconstruction

The main objective of action C1 was to reconstruct the sill at Zalog. The sill controls the water level of the Ljubljanica River. In the past, the sill was damaged and, for various reasons, became non-functional, which deteriorated the conditions in the oxbow upstream. If these damages continued to increase, the excessive gaps between the rocks would result in a decreased ability or even inability for the fish to migrate upstream.

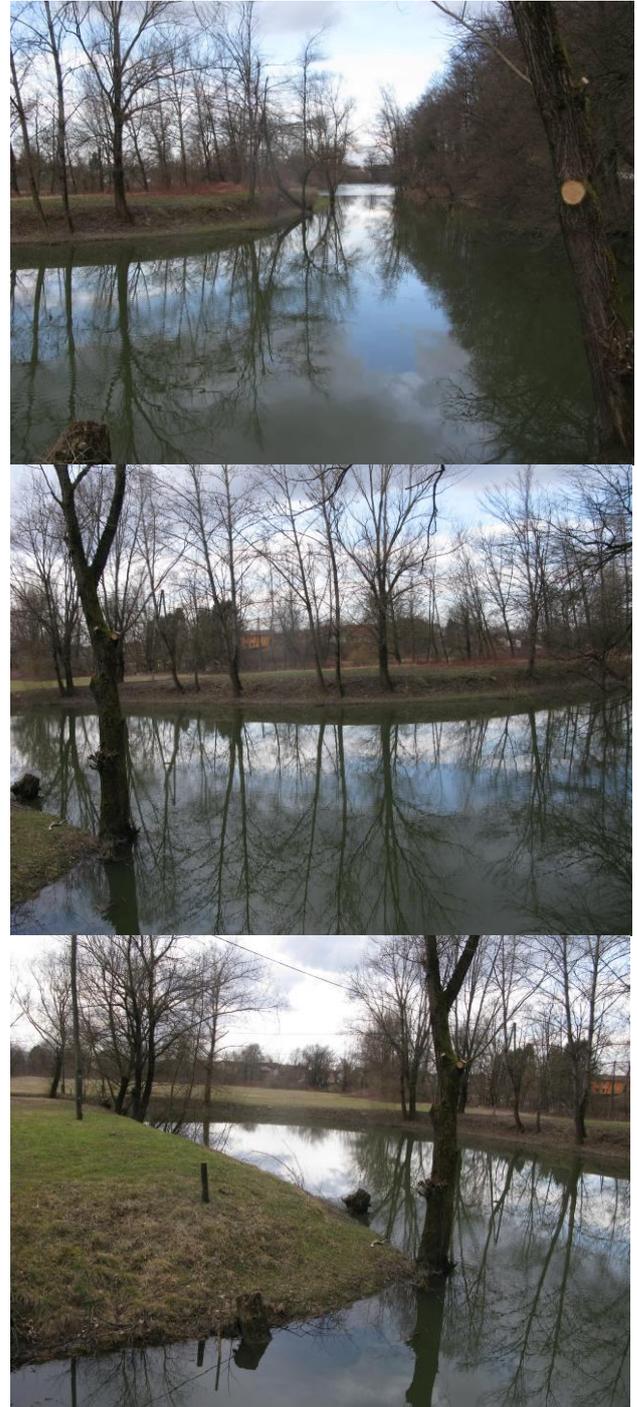
After reconstruction

The restoration of the sill improved the ecological conditions of the Ljubljanica particularly during low flows, when the water level was too low to provide enough hiding places for the water organisms, particularly fish.

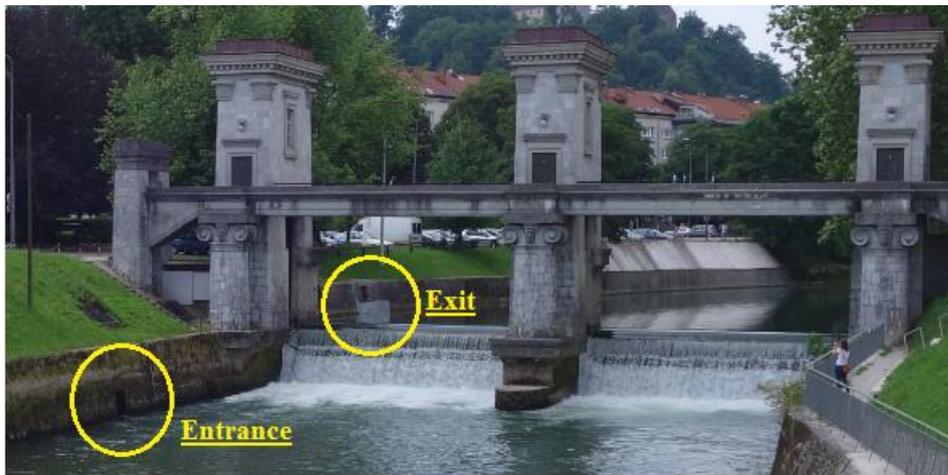
Figure 20: The location of the fish pass at the right bank along the sluice gate at Ambrožev trg, with marked fish pass entrance and exit.

The restoration works were divided into two stages: the restoration of the inlet part of the fish pass and the cleaning and restoration of the fish pass interior. At the fish pass inlet (fish pass exit), the grill for the holding of debris, which was out of function, was replaced by a debris deflector installed on guides fitted to the bank wall.

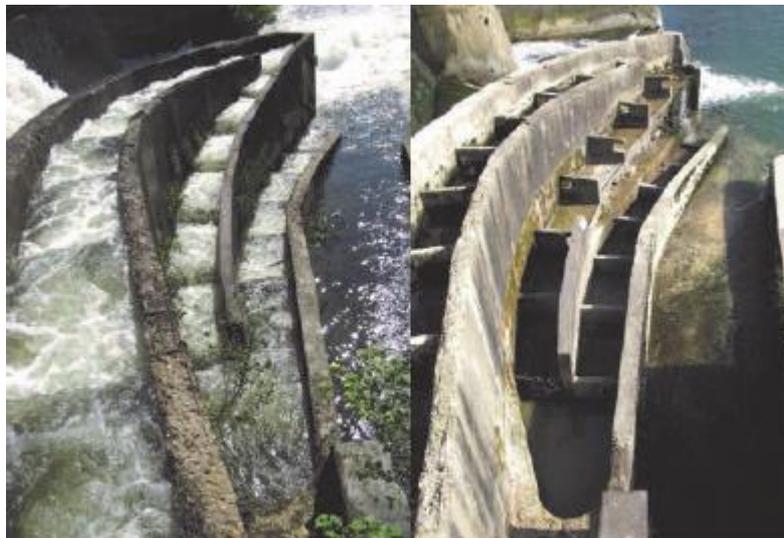
Figure 21: The fish pass at the Fužine weir prior to the restoration and its collapse (left) and after the collapse in autumn 2013 (right).

The restoration works at the fish pass at Fužine were scheduled to take place after the completion of the works under action C1, i.e. in the beginning of 2014. Unfortunately, in November 2013, the fish pass collapsed due to high flows, i.e. water forces acting on the fish pass walls (Figure 21). Field visits showed that the original restoration plan was not suitable, i.e. that the implementation of the originally planned works would not help us reach the project objectives of restoring the functionality of the fish pass at the Fužine weir. New design concepts and design of restoration measures had to be produced, which led to a delay in the start of works. A more careful planning was required, because the structure was more damaged than originally thought. This became apparent already during the collapse of the structure. However, it turned out that the costs of restoring the entire fish pass were considerably lower than if the fish pass had been restored only partially. Namely, the reconstruction of the entire structure is less complex and thus also cheaper.

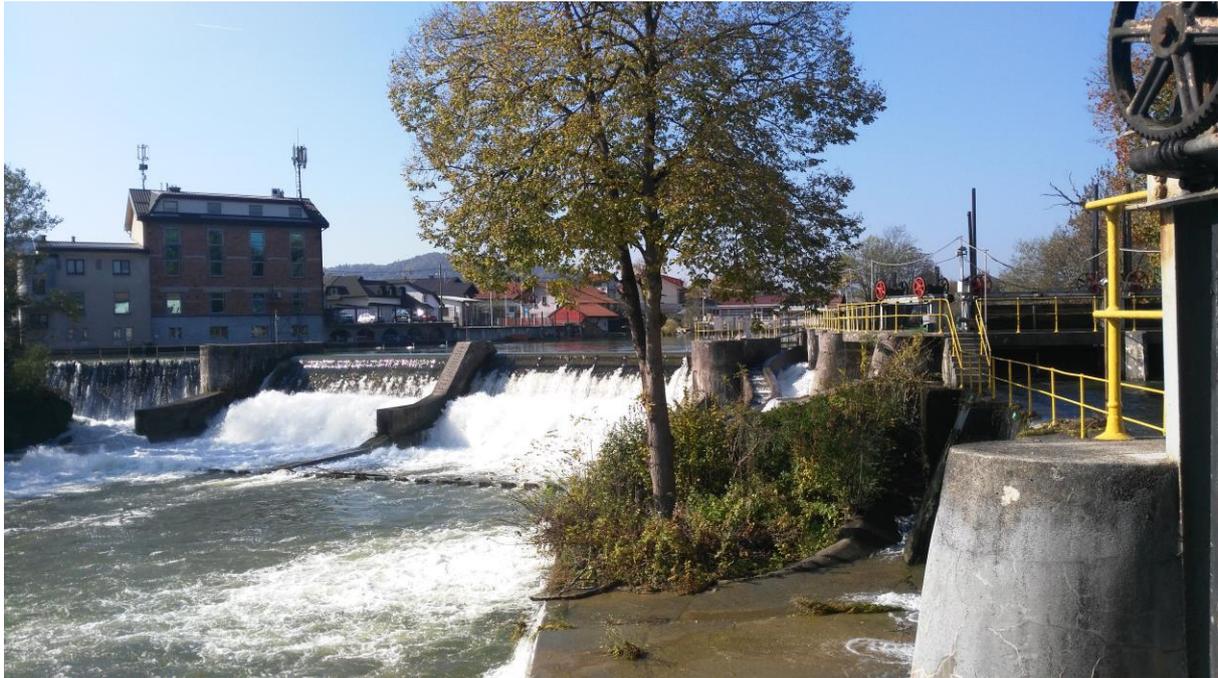
Figure 22: Weir at Fužine (left) and fish pass (right) after reconstruction works

The reconstruction of the fish pass at Fužine restored the longitudinal connectivity of the Ljubljana River between its mouth into the Sava River and the sluice gate at Ambrožev trg. Following the restoration of the sluice gates at Ambrožev trg, the connectivity was improved all the way to the upstream parts of the Ljubljana River.

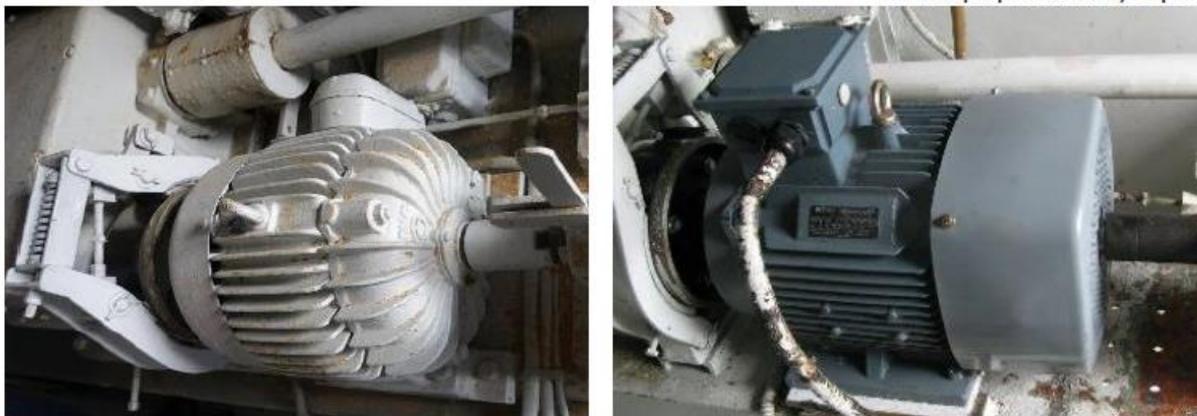
Figure 24: The outdated engine (left) was replaced by a new one (right)

- The work on the barrier was supervised by the concessionaire of the barrier Hidrotehnik d.d. (Annex 18).
- Works were carried out in August and September 2015. The outdated engine was replaced by a new one (Figure 24).

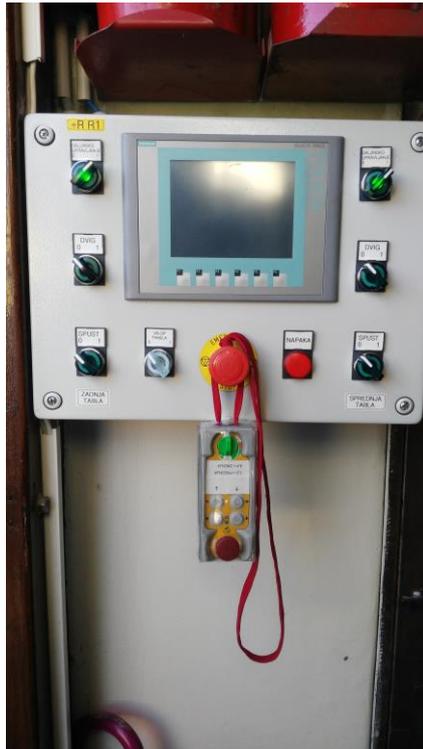
Figure 25: The touch screen displaying the position of the (right) barrier.

- A touch screen displaying the position of the (right) barrier was added (Figure 25). The refurbished barrier propulsion system now allows the movement up to 200 mm above the threshold with the lowest step of 5 mm (Figure 25).

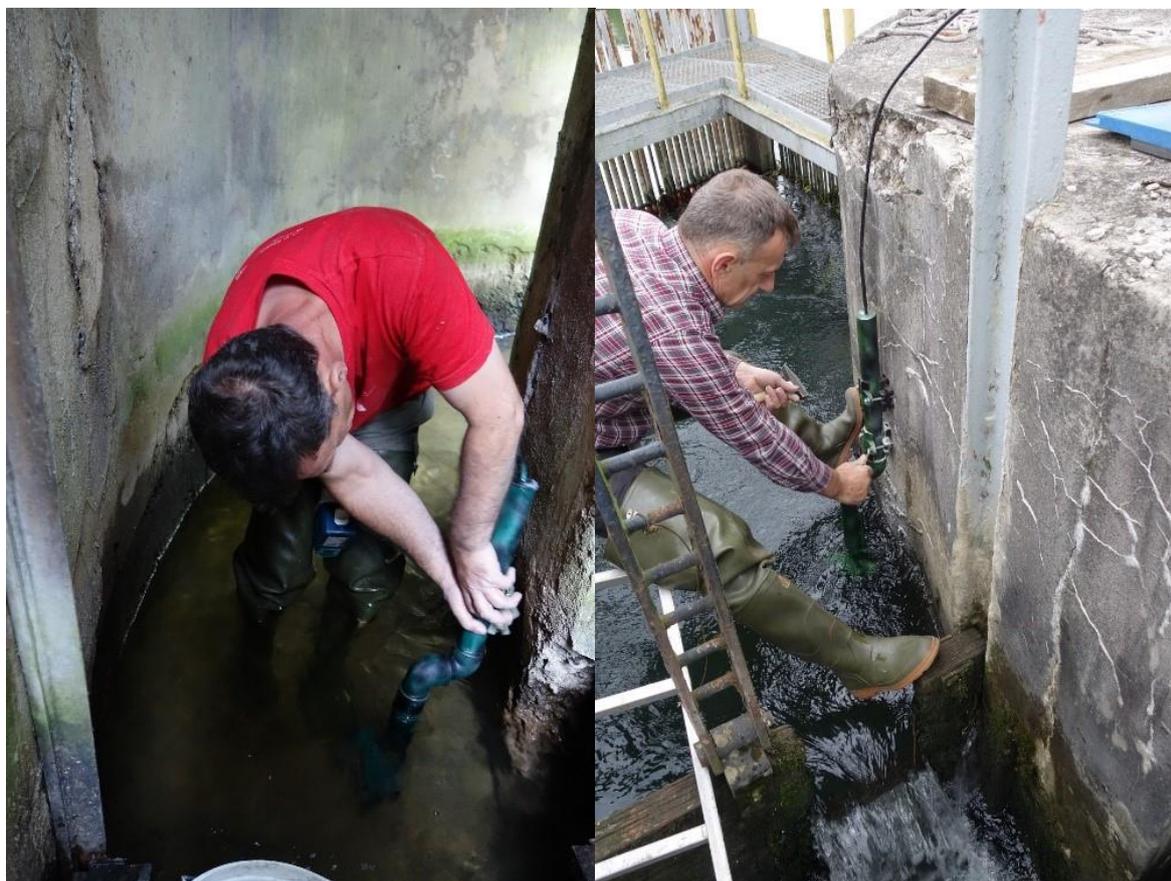
Figure 27: Installation of the fish monitoring camera in the fish pass at Ambrožev trg (left) and at the fish pass at Fužine (right).

After having poor results using VIE tagging, we decided to build and use cameras in fish migration monitoring. The cameras were installed in both fish passes. The first camera for monitoring fish migration was installed in the fish pass at Ambrožev trg at the beginning of June 2015 when the reconstruction of the fish pass was finished (action C2) (Figure 27, left). Right after the completion of works at the fish pass in Fužine in September 2015, the second camera was also installed there (Figure 27, right).

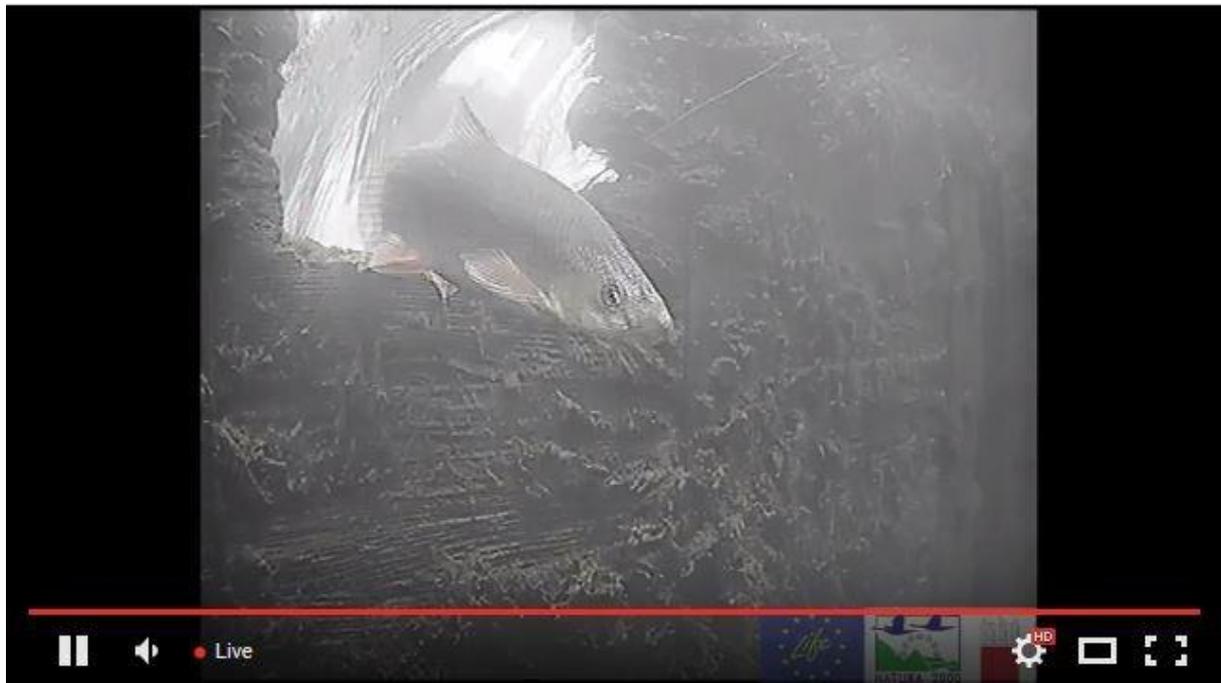
Life - Ljubljana povezuje FishCam Fužine

The first type of cameras was installed at the Ambrožev trg fish pass while the second type was installed at both Ambrožev trg and Fužine fish passes. Together with both types of

cameras we detected 12 different fish species passing one or the other fish pass, including all three target fish species.

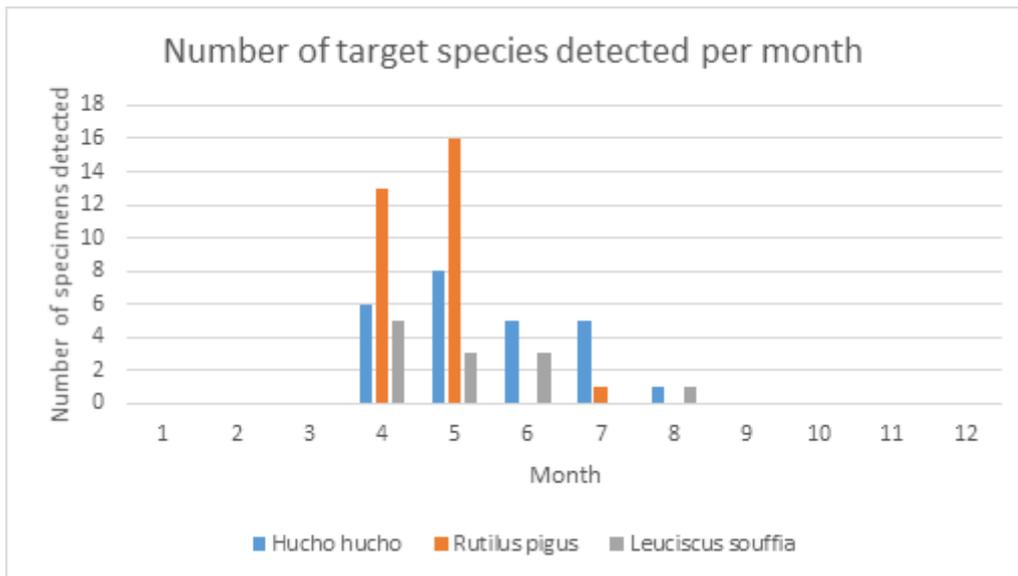
Figure 29: Number of target species detected per month

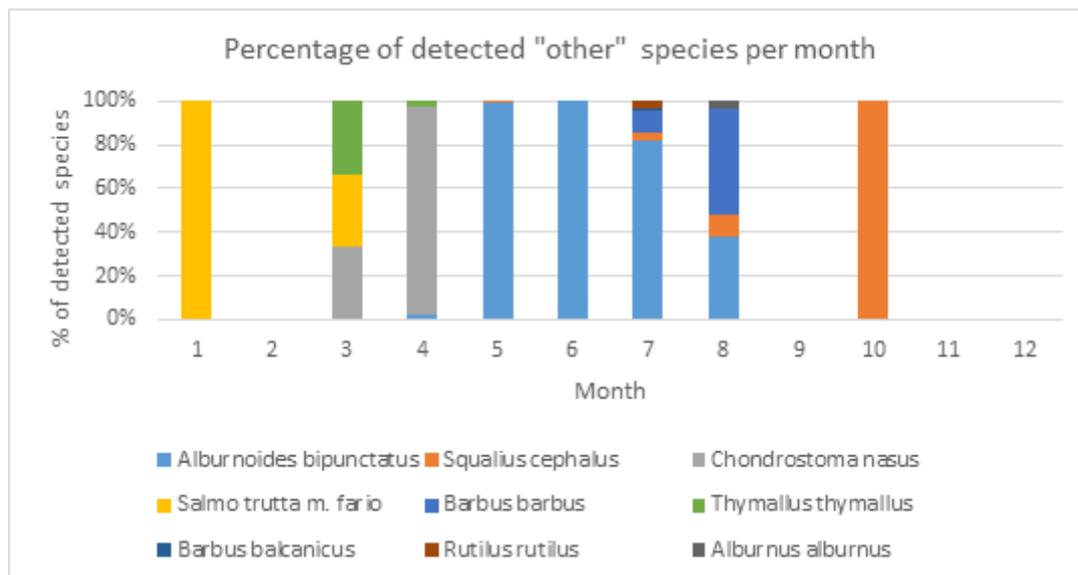
Figure 30: Percentage of detected "other" species per month

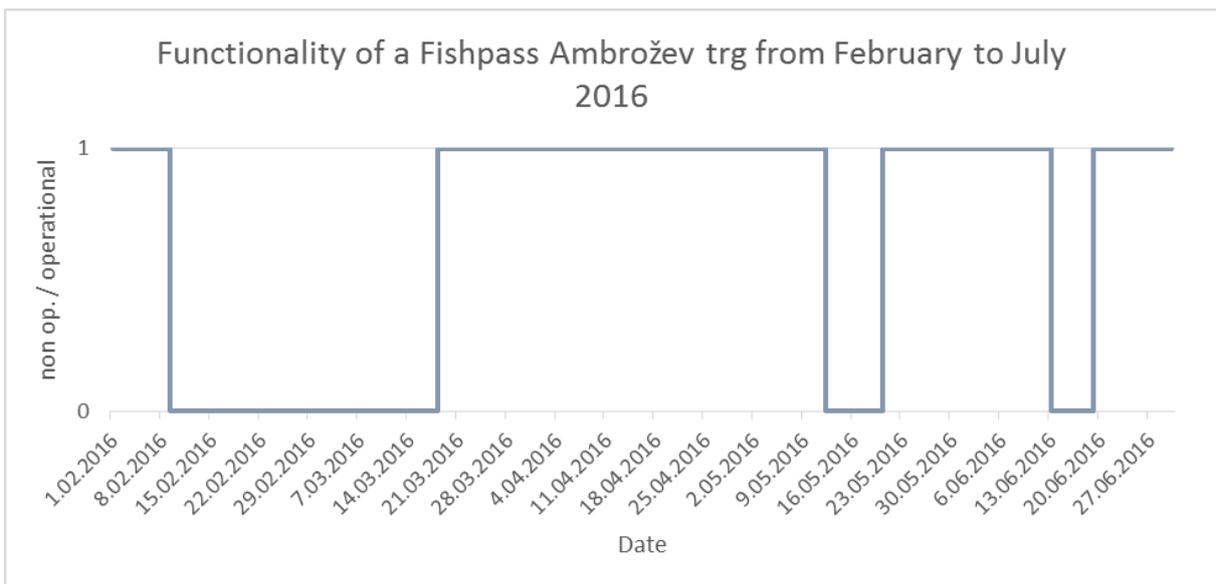
Figure 37: Functionality of the fish pass at Ambrožev trg (February–July 2016)

There is a pressure sensor installed at the Ambrožev trg gate for monitoring the water level at the fish pass inlet. Based on the data obtained using the sensor, we produced a graph showing the functioning of the fish pass between 1 February 2016 and 1 July 2016.

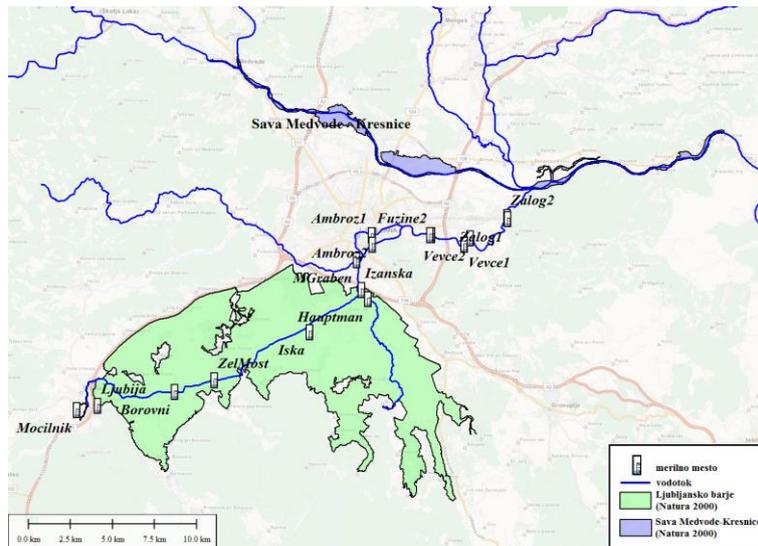
Figure 39:17 locations of measurement sites and Natura 2000 target sites of the project (Sapač et al., 2014)

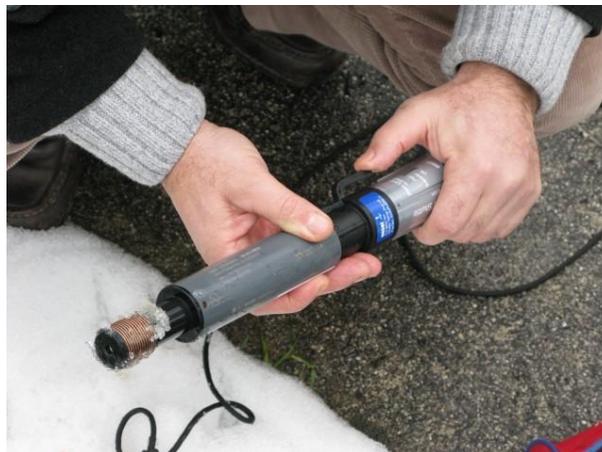
Figure 40: Collection of measured data in the field

Discharge was regularly measured in various locations of the Ljubljanica and its tributaries (e.g. rivers Unica, Iščica, Planinsko polje). The checking of monitoring sites and the instruments installed is carried on a monthly basis. During the project, more than 150 field checks (i.e. field visits) were done. Field checks are carried out by a researcher employed at the University of Ljubljana, Faculty of Civil and Geodetic Engineering (Figure 40).

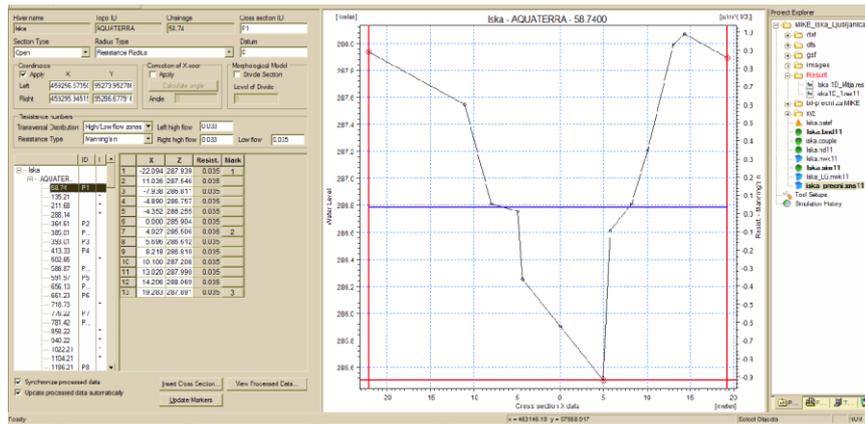
Figure 41: One of the cross-sections of the Iška River in the hydraulic model

The hydraulic model was established as part of action A3. Under action E3 the model was, will continue to be, calibrated with the data obtained at the 17 measurement sites on the Ljubljanica river and its tributaries (set up under action A3). Besides, the data from the Slovenian Environment Agency were obtained. The Agency is responsible for monitoring surface waters in the Republic of Slovenia. The hydraulic model was developed and calibrated by the researchers of the University of Ljubljana, Faculty of Civil and Geodetic Engineering (Figure 41). A more detailed description on the hydraulic model is found in Annex 14.

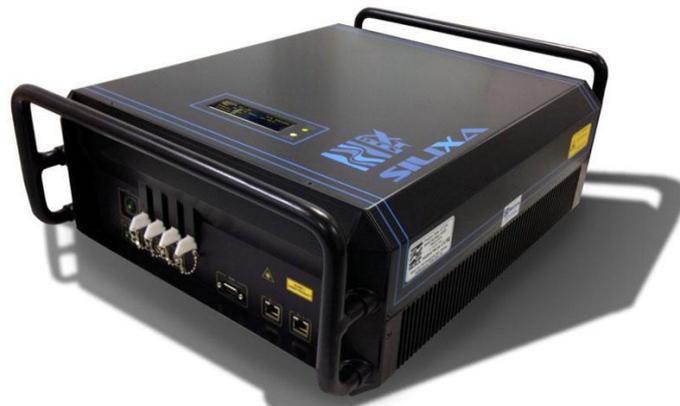
Figure 42: SILIXA ULTIMA-XT DTS Range 5 km

The network of measuring stations is relatively dense. However, these measurements still provide only point data. The Ljubljana River basin is partially karstic, so all waterways are not known. To build a good hydrological model we must know the river basin water balance. One way of discovering underground springs is to measure temperature changes. For this purpose, in the framework of this project 2 km of optical fibre for measuring temperature changes and a sensor (SILIXA ULTIMA-XT DTS Range 5 km, Figure 42) were purchased. University of Ljubljana carried out several measurements in the Ljubljana River and its tributaries (e.g. Iščica, Želimeljščica, Borovniščica) (Figure 43, Figure 44). A more detailed description of the sensor and optical fibre operation is provided in Annex 19.

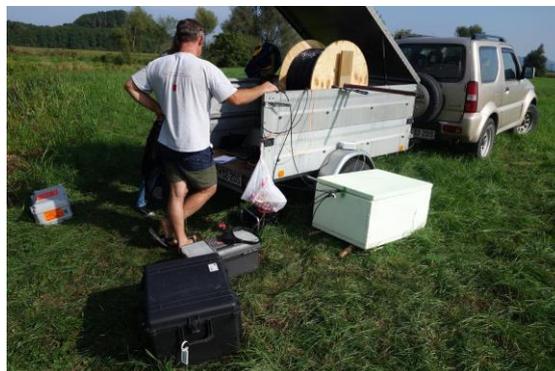
Figure 43: Field measurements: Iščica River on 2 September 2015

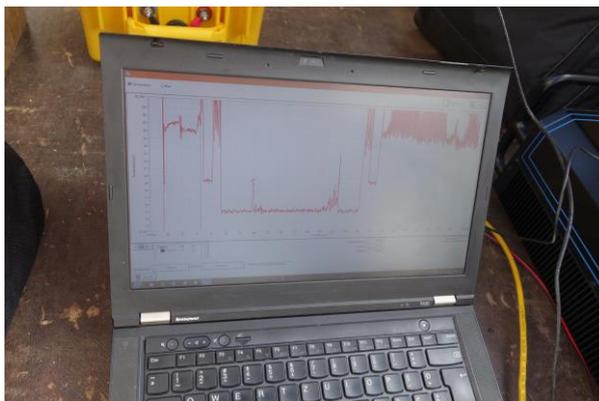
Figure 44: Very precise measurement results using the SILIXA optical fibre and sensor

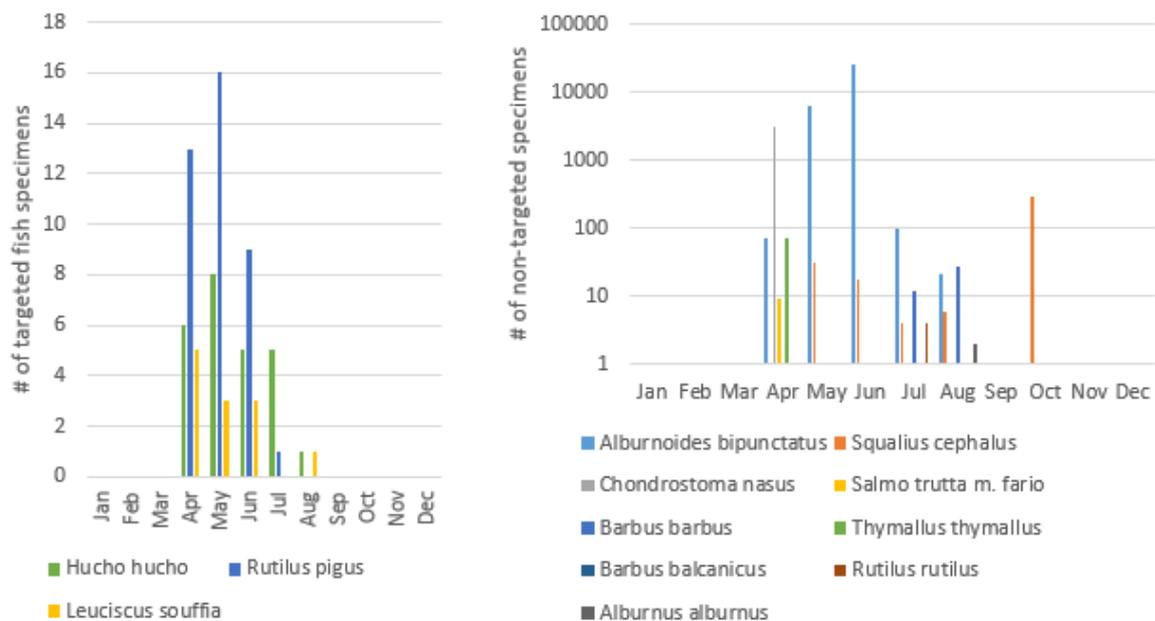
Figure 55: Number of targeted and non-targeted fish species detected per month

The measures taken within the framework of the project (reconstruction of fish passes, upgrading of the gate lifting system, installation of deflectors at the exits of fish passes, reconstruction of the stone sill at Zalog, etc.) will make a significant contribution to realising the goals of the Habitats Directive (Council Directive 92/43/EEC of 21 May 1992 on the conservation of natural habitats and of wild fauna and flora), stating that “the aim of this Directive shall be to contribute towards ensuring bio-diversity through the conservation of natural habitats and of wild fauna and flora in the European territory of the Member States to which the Treaty applies”. *This goal will be achieved with an increased population of targeted fish species. Benefits concern also increase of the fish habitat in general, which will become much larger due to the re-established connectivity achieved by enabling of fish passes and removal of barriers along Ljubljana River.* The results of monitoring the passage of fish through the fish passes clearly demonstrate that target fish species use the fish passes restored in the project (see Figure 55). Future monitoring will reveal whether the provided passage through the fish passes contributes to the population size of the target fish species. *Monitoring data will improve the knowledge of the state of targeted fish species and will in future allow us to recognize potential threats.*
